## 1987 MERCEDES-BENZ 560 SL

VIN WDBBA48D4HA074773 · 78,750 miles · 39 yrs old

### SCOPE OF WORK

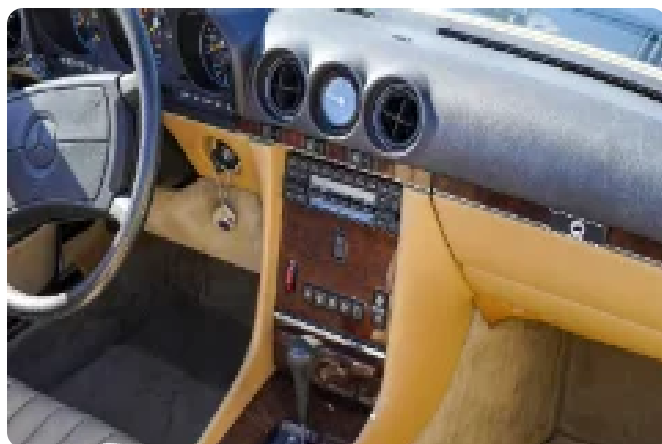
Dashboard

The cabin features original tan leather upholstery presenting in above-average, highly original condition. All factory gauges, switches, and interior electronics were tested and observed to be fully operational. The primary cosmetic defect is a visible stress crack on the passenger-side dashboard fascia adjacent to the radio unit. The leather seating shows minor, uniform surface color fading consistent with age, but remains structurally sound with zero rips, tears, or seam separations.
